# Steering Intermediate Shaft Knocking Noise

YEAR(S)	MODEL(S)	ADDITIONAL INFORMATION
2009 – 2010	Corolla, Matrix

Some 2009 – 2010 Corolla and Matrix vehicles may exhibit a clunk, pop, or knocking noise when turning the steering wheel to the left or right. A new intermediate shaft has been developed to address this condition. Use the following repair procedure to remove and replace the steering intermediate shaft.

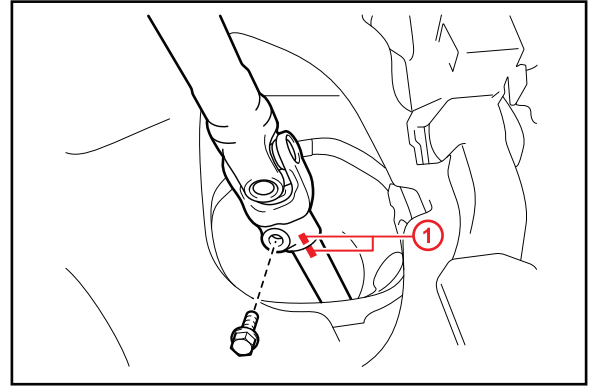
**Figure 2.**

<b>1</b>	<b>Matchmark</b>
----------	------------------

- Place a matchmark on the No. 2 steering intermediate shaft that will later be copied onto the new part, and remove the bolt.

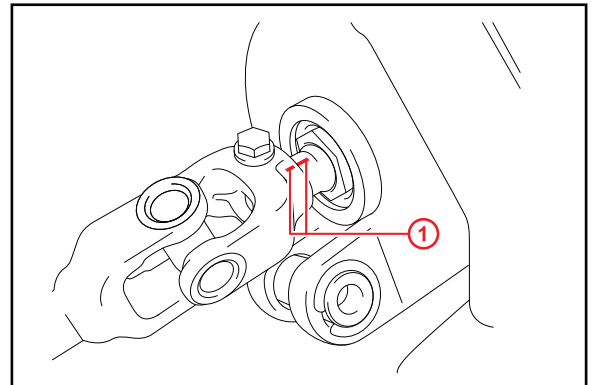
**Figure 3.**

<b>1</b>	<b>Matchmark</b>
----------	------------------

- Place a matchmark on the upper portion of the No. 2 steering intermediate shaft.

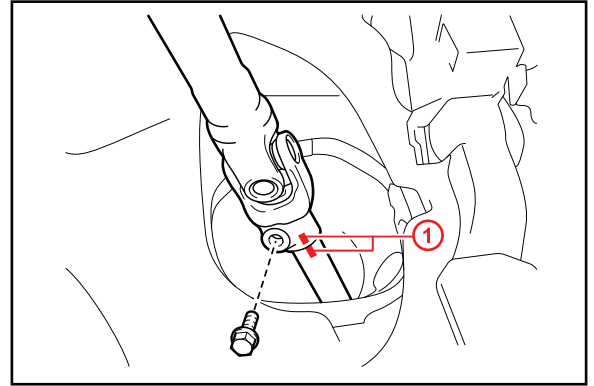
**Figure 7.**

<b>1</b>	<b>Matchmark</b>
----------	------------------

8. Install the No. 2 intermediate shaft onto the No. 1 intermediate shaft and line up the matchmarks, and tighten the bolt.

**Torque: 35 N\*m (360 kgf\*cm, 26 ft\*lbf)**
